## How to change your governor gear

Steve Johnson 8/7/19

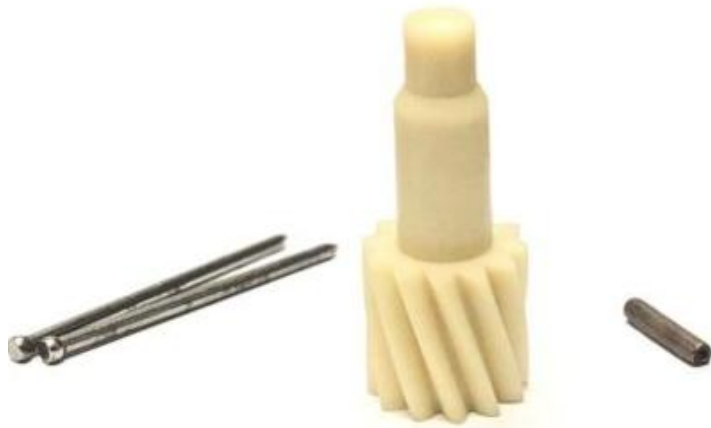
Governor gear repair kit - \$9.99 with free shipping on eBay. Original GM part number 8624939 = K34411A manufactured in USA by Southeast Industries. Includes 2 nails (to pound out old roll pin and install new one – I used a punch instead) and a replacement roll pin. Don't forget to carry a 1/8" diameter drill bit too so that you can drill the hole through this gear for the roll pin installation.

There was one more hurdle to overcome. The replacement plastic governor gear is made without a hole through it for the roll pin that holds it in the governor shaft . During assembly, you press the gear into the shaft then drill a 1/8” diameter hole through it using the existing holes in the steel shaft as guides. I had carried a 1/8” drill bit with my “spare parts” governor gear, but had never given a thought about a drill motor to make the drill bit useful. No problem – Jim Wagner was at the rally and volunteered that I could use his drill motor.

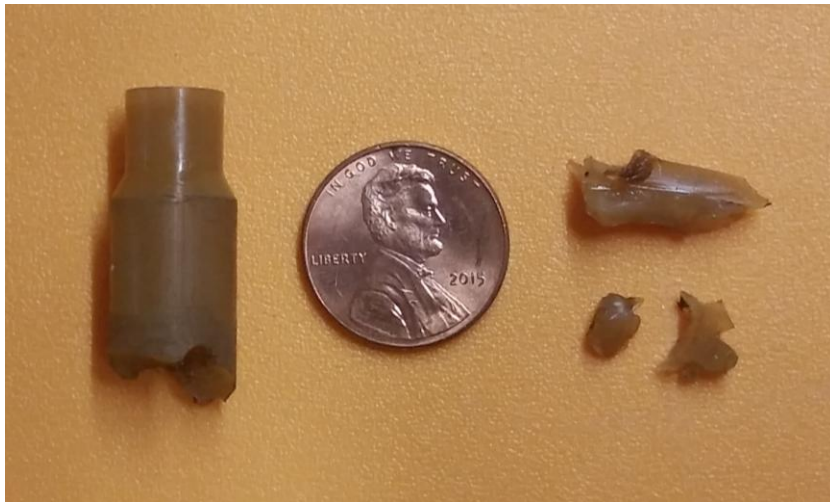
To the left of the penny is the shank of the gear that was still in the governor shaft when we removed the governor assembly from the transmission. To the right are the only pieces of the broken governor gear that I found in the transmission pan after I got home. Perhaps the others were captured in the filter or have not made it to the pan yet.

With the governor removed, we were surprised to find exactly how the plastic governor gear had failed. I had expected to find a gear with worn teeth that would cause it to not rotate the governor shaft as intended. Instead, we discovered that the gear had sheared into two pieces right where it is weakened by a roll pin that attaches it to the governor shaft. Therefore, we had half of the gear in our hands but the other half was still in the transmission – out of reach about 4" down a narrow bore. How in the world to get out the broken part? For a couple hours, we experimented with things like dum-dum on the end of a long screwdriver trying to adhere to the broken gear so that we could lift it out of the transmission, but nothing worked. We decided to buy some 4" long construction screws with the hope of threading one into the broken plastic gear to then lift it out. Off to Home Depot John and I went.

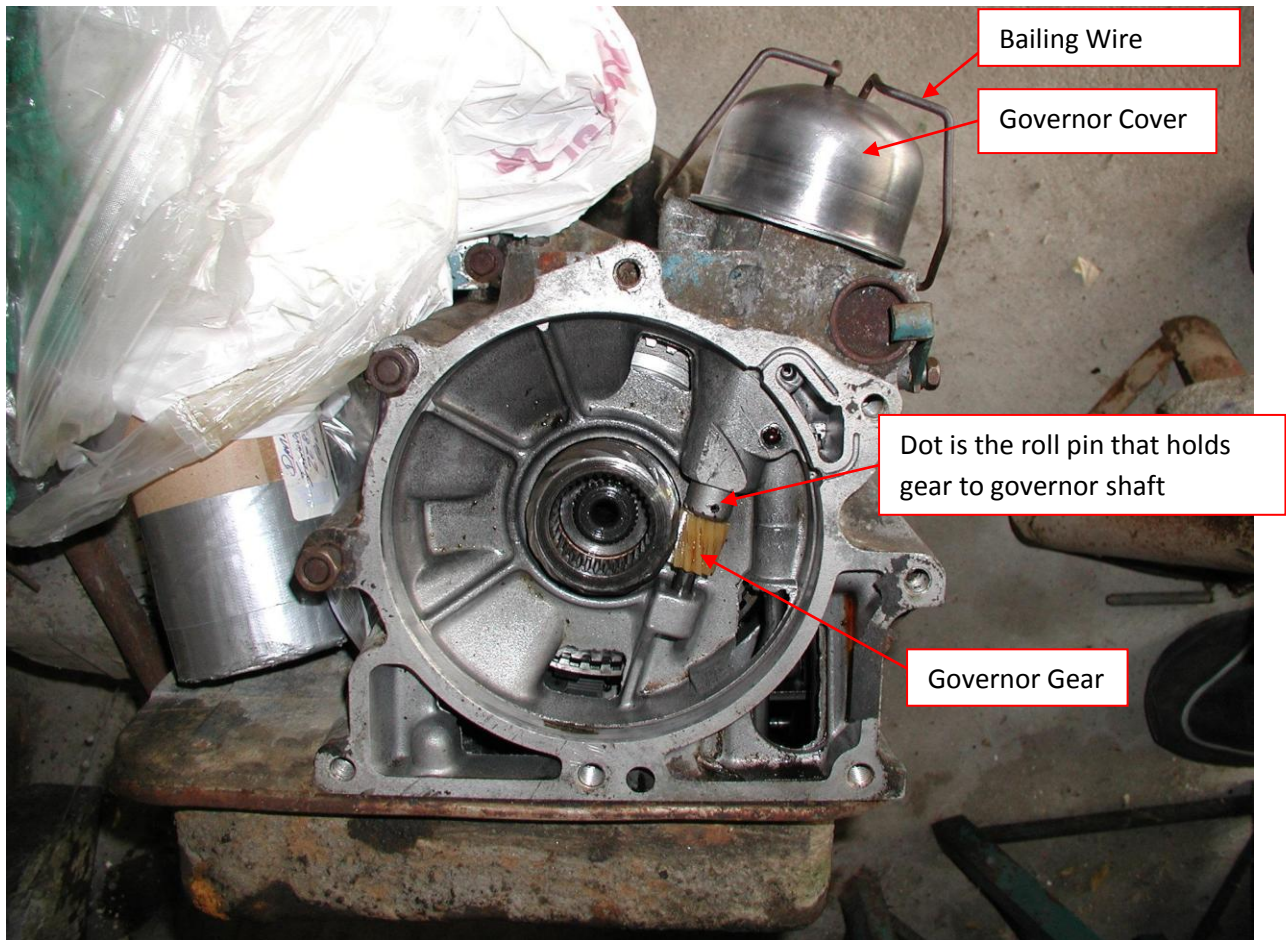
You won't see this view of the inside of the transmission but the photo might help understanding of how things fit together. The bailing wire swivels to the front or rear so that the complete governor assembly from the cover down to the plastic gear can be lifted up and out of the transmission housing.

Since my vehicle has headers, I needed to remove the driver's side header to be able to remove the governor from the transmission. This required removing the transmission fluid dipstick tube and disconnecting the engine oil dipstick tube at the service joint near the left side rocker cover. About as soon as I got started, John Koenig showed up to help. With John's help, things came apart quickly until it was time to remove the governor. The speedometer cable was disconnected from the governor by simply loosening a knurled nut. However, the bailing wire that holds the governor in place (much like a bailing wire holds on the master cylinder cover) was seized in the transmission housing by 40 years of corrosion. Fortunately, we were able to dislodge one end of the bailing wire and bend it out of the way to allow lifting the governor from the transmission.
